Lab Report 2

2.008 Spring 2019

I. Machining

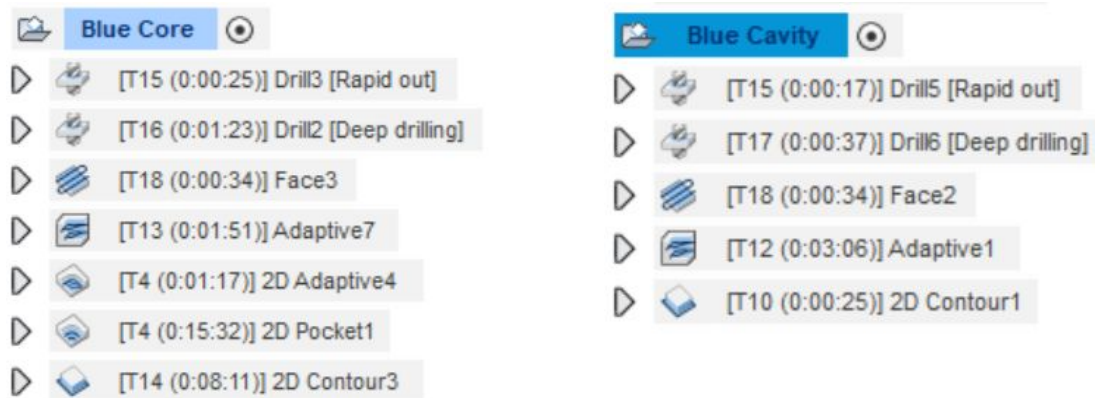
Figure 2: These are the toolpath operations for the blue body mold core and cavity. Both toolpaths begin with center drilling, then deep drilling of either the ejector pin holes or shoulder bolt hole, followed by facing the top of the stock to create a uniform and smooth model top. Next adaptive toolpaths are used as a roughing pass to clear material into the general shape of the mold before finally a finishing toolpath with a smaller vertical and horizontal stepover is used to create a smoother surface finish.

The blue body is our simplest part so it was the easiest and quickest mold to make. The core side took 29 minutes to machine and the cavity side took only 5 minutes to machine. The toolpaths for the mold halves were as follows:

We choose to use 5000 RPM for the spindle speed for every operation because that is the maximum speed of the milling machine. Since the machining time was short for these mold halves with the default feed rates, we used the pre-set feed rate values for all of the operations. In practice we would often slow down the feed rate to 30-40% of the programmed value when just starting an operation to make sure the toolpath was doing what we expected it to do before ramping up to 100% of the programmed feed rate. We were successfully able to machine this blue body mold on our first attempt.

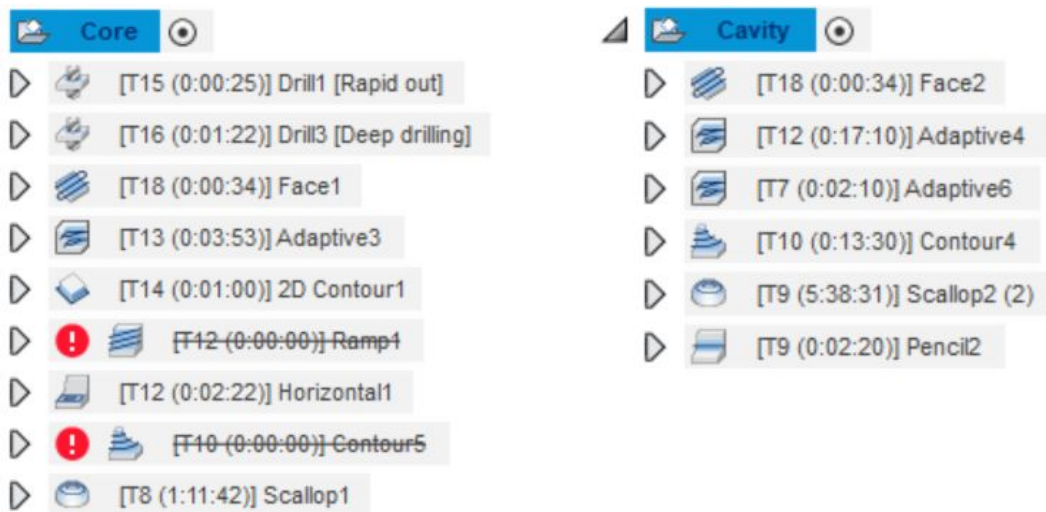
Figure 5: Toolpath operations for the yellow body core and cavity molds. The core toolpath begins with centre drilling followed by a deeper drilling operation for ejector pin holes. Both cavity and mold toolpaths include a facing operation of the stock top to create a smooth top surface. Facing is followed by adaptive passes to remove as much material possible. On the cavity mold, a contour operation is run to remove the majority of material on the hair and mouth features prior to transporting the mold to the HAAS. This contour operation is important to carry out in order to prevent the endmill from breaking on the HAAS. On the HAAS, the finishing scallop (0.002" stepover) and pencil toolpaths are used to reach material between small features, and create a smooth surface finish.

We chose to use 5000 RPM for the spindle speed for every operation because that is the maximum speed of the ProtoTRAK milling machine. The only exception is the spindle speed set for the scallop operation for the cavity mold, which was set to 7500 as it was carried out on the HAAS to speed up the operation. Since the machining time

was relatively short for the core mold, we used the pre-set feed rate values for all of its operations. Again, for the scallop operation of the cavity mold, along with the spindle speed change, the feed per tooth was set to 0.00075 in-- much smaller than the default value, to get a better surface finish in a shorter time interval. In practice, we would often slow down the feed rate to 30-40% of the programmed value when just starting an operation to make sure the toolpath was doing what we expected it to do before ramping up to 100% of the programmed feed rate. We were able to machine two iterations of the yellow cavity mold. The first mold iteration did not result in favorable outcomes due to errors in machining and choice of tools. The order of operations on the first core mold was incorrect as the 5° drafting tool had to plunge into a pocket of material rather than simply drafting a vertical surface once all material was cleared. Additionally the toolpath created for the overnight HAAS operation on the cavity did not leave a smooth surface finish and messed up the parting surface of the part by removing material along the perimeter so the part was no longer circular or flush. In our second iteration, the mold was placed on the HAAS, however, after the job was initiated, the 1/16th endmill used for the scallop operation broke when trying to remove material from around the mouth and hair features. This was because endmill attempted to remove large chunks of material around the very narrow areas of the mouth and hair. We revisited our design, and introduced a contour operation on the ProtoTRAK preceding the scallop operation on the HAAS, which removes as much material possible around the two small features of the hair and mouth. Even though the surface finish is poor on our second attempt, the mold halves successfully fit together so we were able to try to injection mold.

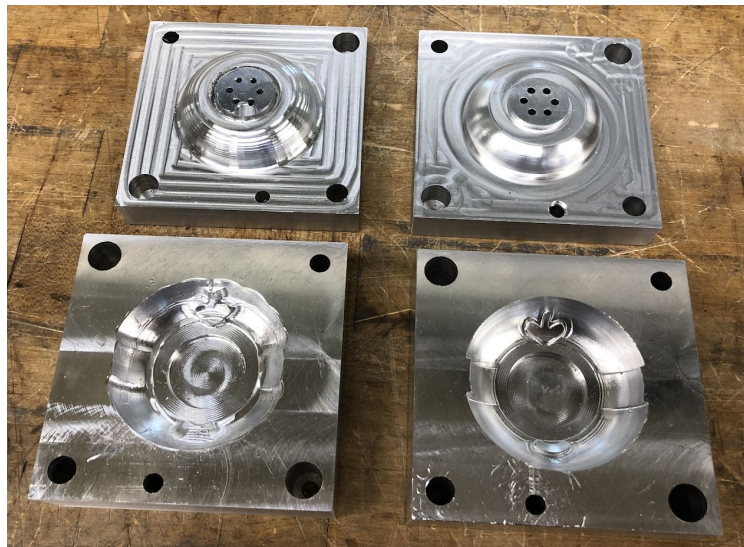
Figure 6: Two attempts at the yellow face mold. Our first attempt on the left has order of operation errors on the core and toolpath errors on the cavity. Our

second attempt successfully made the yellow face core however the cavity side surface finish is poor due to the tool breaking during the overnight HAAS operation.

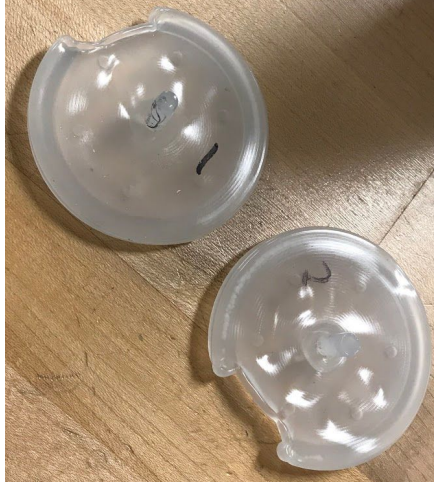
Figure 11: Attempts #1 and #2 at injection molding. Short shot and dishing occurred in both of these parts, due to shot size being too small (1.50in), and ejector pins that were too long (5.375”).

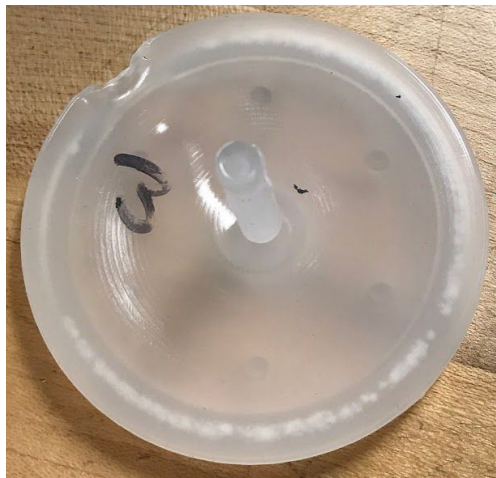
Figure 12: Attempt #3. Increased shot size to 1.75in, and shortened ejector pins. There's less dishing now, but still short shot in the far side (from the mold) of the part

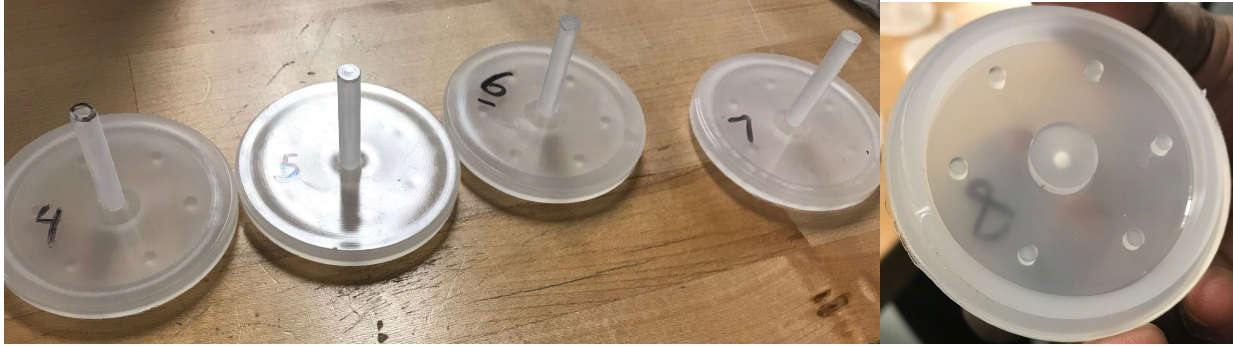
Figure 13: Attempts #4 - #8. Changes are just gradual increases in shot size up to 2.30in, and moving the injection boost pressure up to 1800 psi. There is a weldline that still exists at the far side of the part, but since flashing has occurred, we figured the next change must not have to do with the shot size.

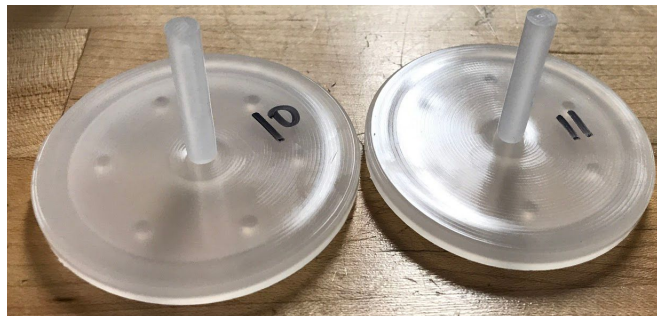
Figure 15: #10 & #11. Increased injection boost pressure to 2300 psi, and reset the injection speed profile. No more burn, but weldline still present.

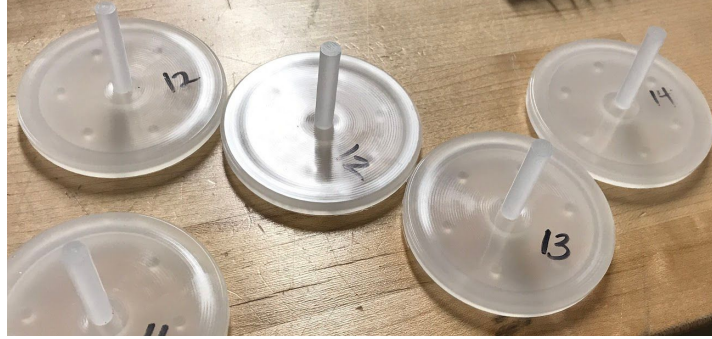
Figure 16: #12 - #15. Increased injection pressure profile from 1299 psi - 1650 psi to 1650 psi - 1800 psi. Ran this configuration four times to allow the machine to “catch-up.” Weldline and flashing still present.

Drawbacks: Obvious drawbacks and defects associated with this first run of blue body parts were the flashing and weldline that were created and left unsolved for the time being. Also, another thing that is not necessarily a “drawback” but a “grain-of-salt” observation, is the fact that we did not have any shoulder bolts with our molds. Obviously, this will be a necessary feature in our final parts, so the parameters detailed here may not hold for the final injection mold.

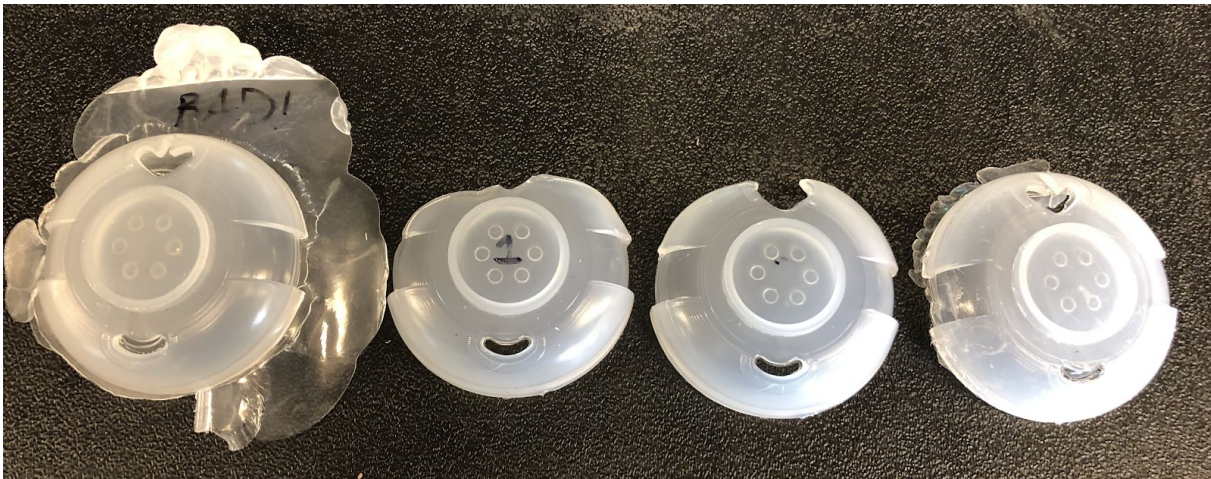
Figure 18: Our four attempts at injection molding the yellow face part. The first and fourth attempt shot sizes resulted in flash whereas the second and third attempts resulted in short shots. We now know our shot size is between 1.2" and 1.4". We had to stop injection molding because the sprue continually got stuck in the cavity side of the mold which forced us to take out the mold and struggle to pry it out.

Injection Molding Parameters: For our first part we started with a shot size of 2.20" which corresponds to the volume of plastic being injected into the mold. This shot size turned out to be way too large and we had considerable flash on our first part. We then reduced the shot size to 1" which resulted in a short shot. For both of these first two parts we had the hold time set to 10 seconds and the cooling time set to 20 seconds. For the third part we increased the shot size to 1.2" and reduced the cooling time to 10 seconds because the part is relatively thin. This shot size also resulted in a short shot. For our last attempt we increased the shot size to 1.4" which resulted in flash. Moving forward we now know that the holding time of 10 seconds and cooling time of 10 seconds work well and that the shot size will be between 1.2" and 1.4".

Drawbacks: With the yellow face, the major drawback was the failure of the part to be ejected from the mold. This may be due to the short depth of the sprue hole on the core side of the mold. There may not be enough depth for the plastic to engage with the

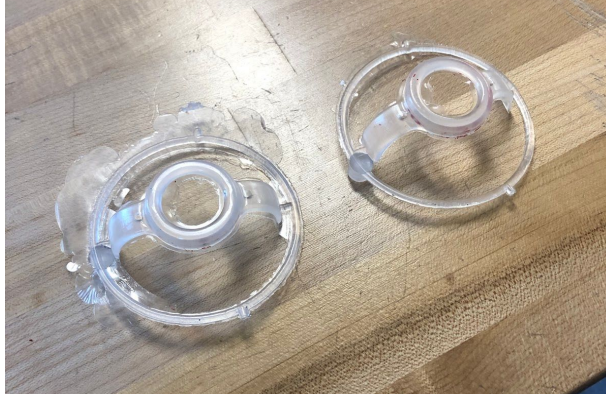
Figure 20: Attempts at injection molding the goggle. Major flashing occurring in the 2nd iteration (left, 1.25 in shot size). Excess plastic removed from 1st iteration (right, 1.50 in shot size)

Drawbacks: The major flashing is the most noticeable defect in the goggle part that must be addressed in future iterative processes with the injection molding parameters. However, one of the major features hindering our progress was the failure of the sprue plastic to eject with the rest of the part. When the molds are both clear, the part fills and ejects perfectly fine, but the plastic in the mold cavity sprue hole stays behind. As a result, any molding you try to do immediately after this fails due to plastic not being able to fill the mold because of solid plastic stuck in the sprue hole. Initial hypotheses suggest that it may either be undercutting between the mold and the mold backing part like in the yellow face part. Alternatively, it can be plastic not fully engaging with threads in the core side of the mold, or the sprue ejector pin being too long for the core sprue hole. There was a lot of aluminum cleared from the core side of the mold, so maybe there isn't enough depth in the hole before the ejector pin fills it.
